**FIRE INVESTIGATION**

**WHARFEDALE GENERAL HOSPITAL, OTLEY,  
WEST YORKSHIRE**

TS03270K-R01-Issue 2

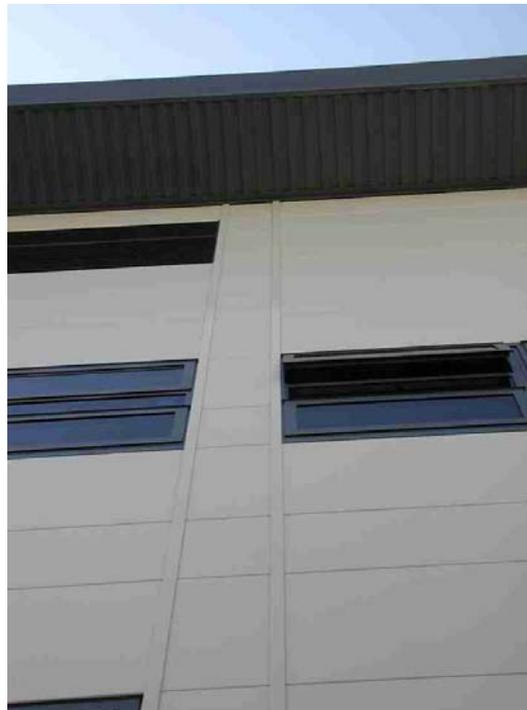
#### **Photograph No 1**

- 4.4 Photograph 1 shows the cladding on an unaffected part of the building.

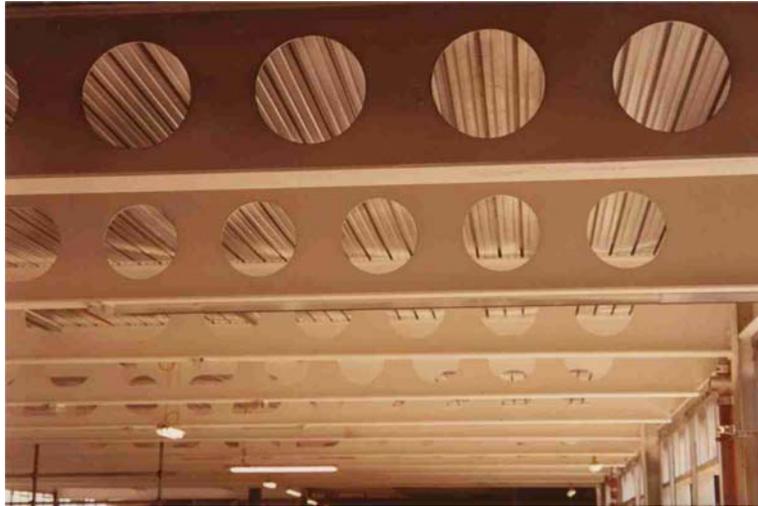
**Photograph No 2**

- 4.5 Photograph 2 shows the beams and profiled steel sheets on an unaffected part of the building.

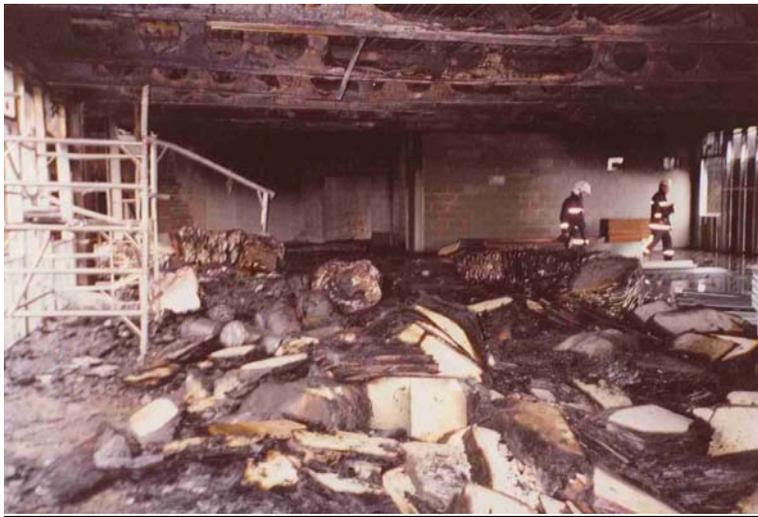
**Photograph No 3**

- 4.6 Photograph 3 shows the fire area on the ground floor.

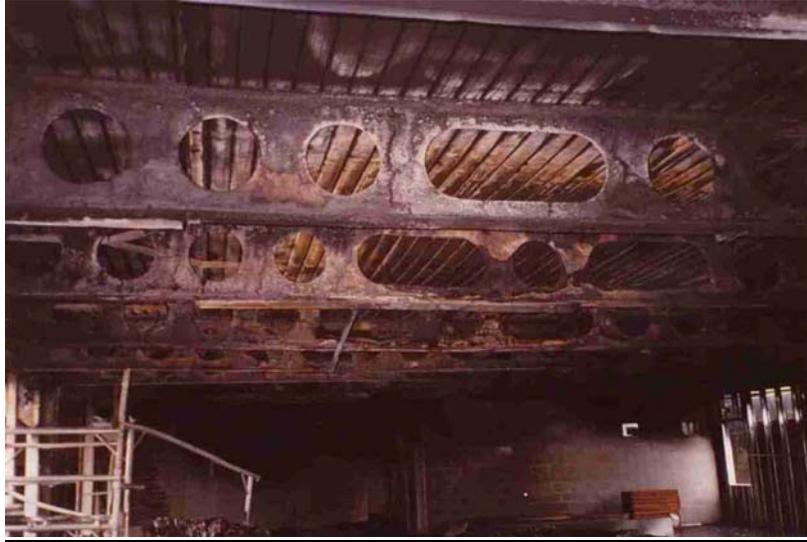
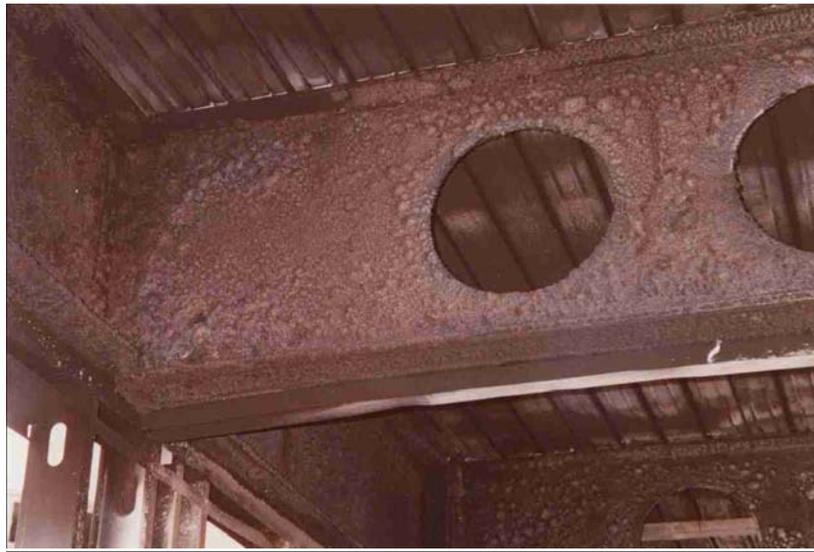
**Photographs No 4 & 5**

4.7 Photographs 4 & 5 show the beams immediately above the fire area on the ground floor.

- 5.6 It is evident from the damage to the intumescent coating to the steel beams and the subsequent distortion and expansion of the steel beams, as reported by ADO Stainthorpe, that the heat generated by this fire was significant (the intumescent coating was rated to provide a one hour standard of fire resistance when tested in accordance with BS 476 yet resisted the fire for less than half an hour in this fire).

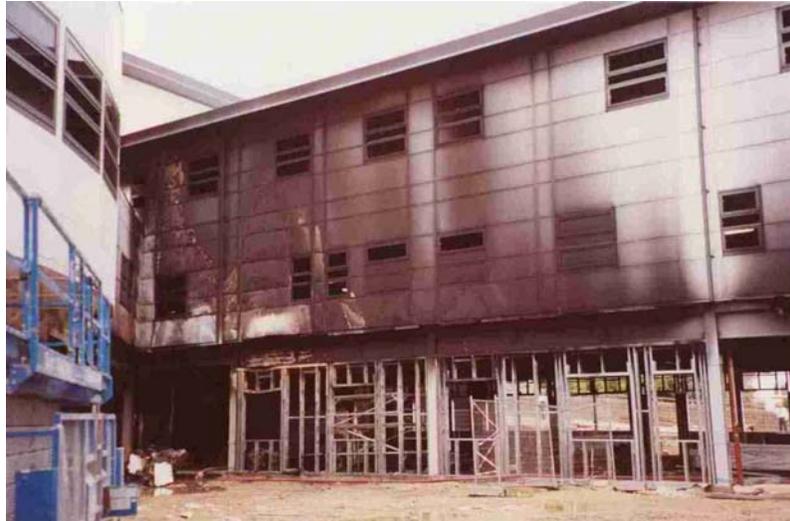
**Photograph No 6**

- 4.8 Photograph 6 shows the outer skin of the cladding on the elevation that faced the quadrangle.

- 5.7 It is also evident, from the damage visible in Photographs 6, 7, 8, 9, 10 and 11 above, that flames attacked the external cladding to the first and second floors. The external skin of the panels has discoloured and distorted.

- 5.8 The inverted “V” pattern of heat damage to the cladding panels is typical of what would be expected from a serious fire burning at a lower level.

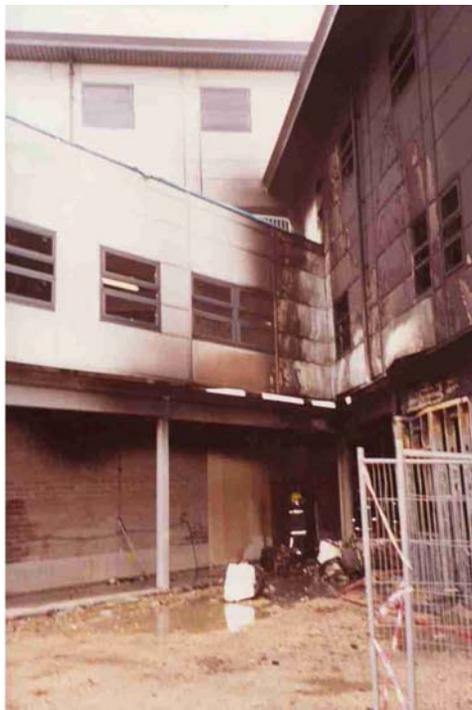
**Photograph No 7**

- 4.9 Photograph 7 shows the corner to the left of the cladding in Photograph 6.

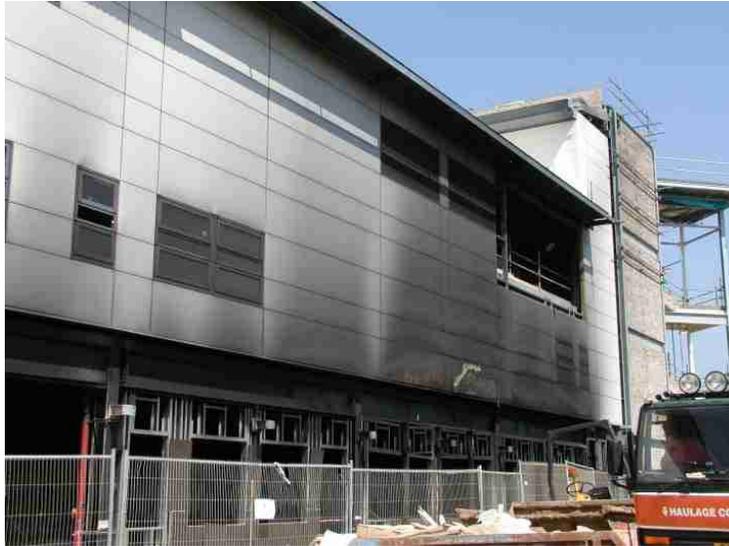
**Photograph No 8**

4.10 Photograph 8 shows the cladding on the elevation on the external face of the building.

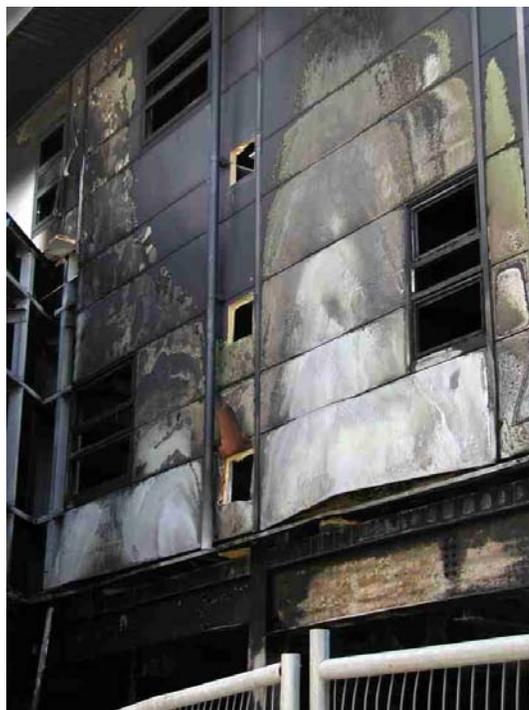
**Photograph No 9**

4.11 Photograph 9 shows sections cut from near the corner shown in Photographs 6 & 7.

6.3 In spite of the significant heat generated by this fire (sufficient to damage the intumescent coating and distort the steel beams); the orientation of the cladding panels (directly above the fire); and the fact that fire stopping was not in place; the cores of the panels, as evidenced in Photographs 9, 10 and 11, did not ignite, did not promote fire spread within the core or to the eaves and did not significantly contribute to the products of combustion.

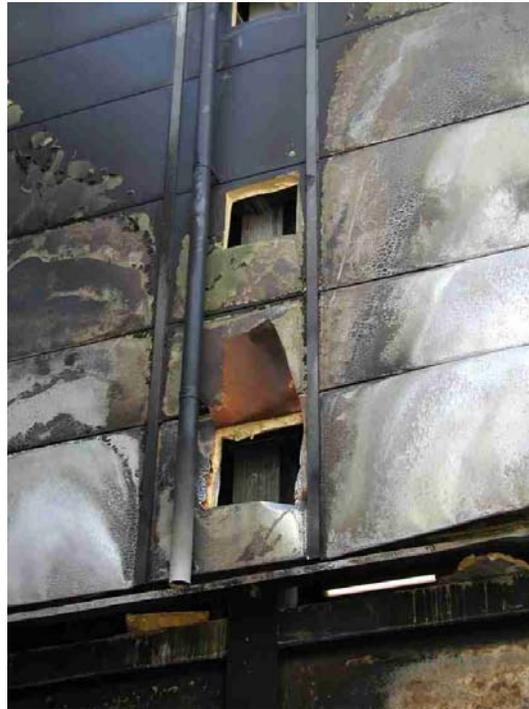
**Photograph No 10**

4.12 Photograph 10 is a close-up of part of Photograph 9.

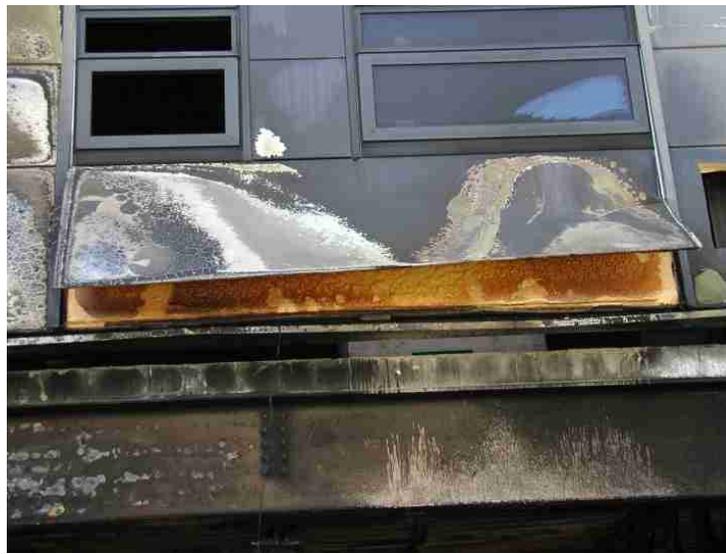
**Photograph No 11**

4.13 Photograph 11 shows the removal of the outer skin of the bottom panel to the right of the panel shown in Photographs 9 & 10.
